HELFRICH-ASSOCIATES ENGINEERING AND CONSTRUCTION CONSULTING

## The DoubleTree by Hilton Hotel at Berkeley Marina

In early 2011 Helfrich-Associates was asked to examine the hotel and evaluate the structural integrity of a portion of the hotel.

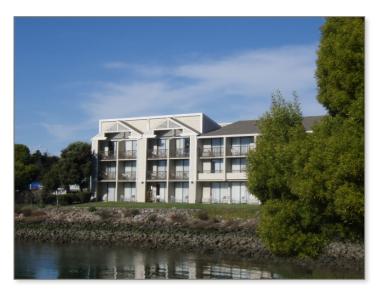
The hotel, built in the 1970s, had a building that was suffering from titling due to uneven soil conditions. The building in question, number three (3), was built on a 12-inch thick, reinforced mat foundation that was not sufficient to deal with the settling of soft soils. As a result the building had tilted more than 20 inches.

Built over a former landfill, the hotel was as close as 20 feet from the bay. Over the years differential settlement had caused cracking of floor tiles, racking of doors and window frames, separation between cabinets and walls, and roof runoff to enter the building.
