Case Study: How the Terms Mouse Trap and Fire Training End Up in the Same Sentence

Helfrich-Associates was called out to a job site in the Inland Empire: A Fire Training Center. This state of the art training center will be utilized by fire departments and students in the surrounding area with every square inch of this training center being built meticulously. There are buildings that are being constructed specifically to be put on fire, but most interestingly, and why Helfrich-Associates is here, is the Mouse Trap.

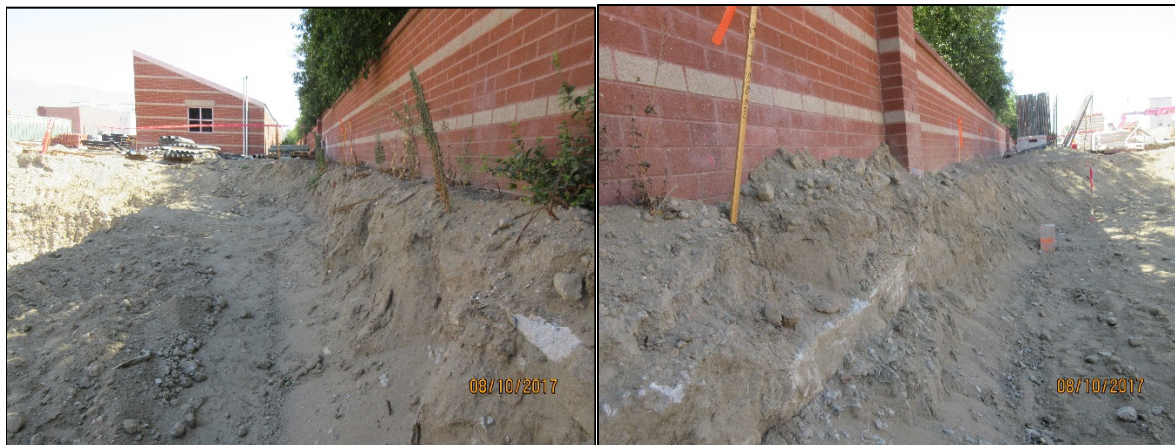
When a Helfrich-Associate representative arrived onsite, there was a large pit set up right against a masonry wall (and property line).

The plan was to excavate and create a Mouse Trap (an underground confined space with tunnels for the trainees to practice lugging equipment around and to create real-life dire situations they will face in the field - hence the term “mouse trap”). The excavation for the Mouse Trap required an approximately 10-feet-high steep slope next to the wall that was planned to remain open for about four to six weeks while the Mouse Trap was constructed.

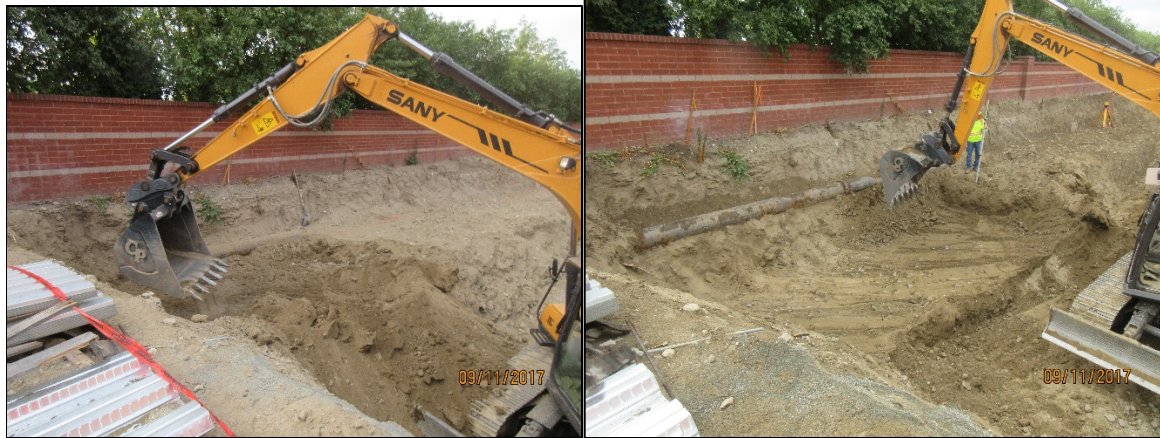
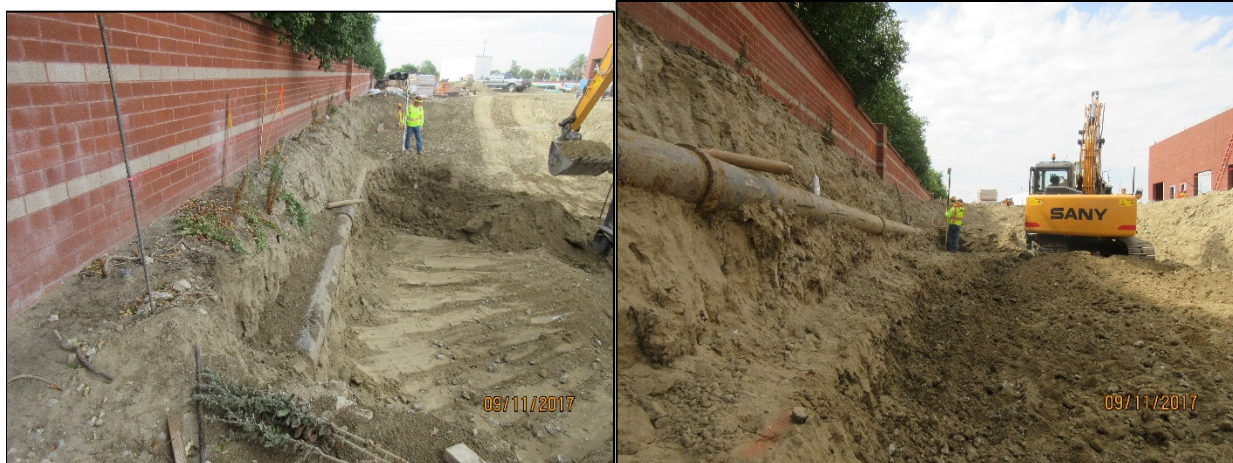
The final excavation side was stepped, with two, 4 feet tall vertical steps, and a 2 feet vertical step at the bottom of the excavation. The pipe that was a couple feet out from the wall was to remain in place and handled with care.

Another site visit took place a couple days later to observe the excavation and to observe the progress of construction. The excavation was extended an additional 18 inches deep to place forms for the proposed wall footings.

It was Helfrich-Associates recommendations that the top of the slope should be carefully monitored when workers are in the excavation, and the excavation should be evacuated if there is any movement or tilting of the wall. During wind storms of greater than 30 mph, work in the excavation should be halted.

The pipe should be braced using diagonal bracing to the bottom of the excavation. Braces should be placed at about 8 feet spacing along the length of the exposed pipe.

Vibrating and plate tamping compaction equipment were not to be used within 10 feet from the base of the excavation. The subgrade soils were adequate to support the expected structure loads, and the soils did not need to be densified or compacted after the footing excavations have been made.

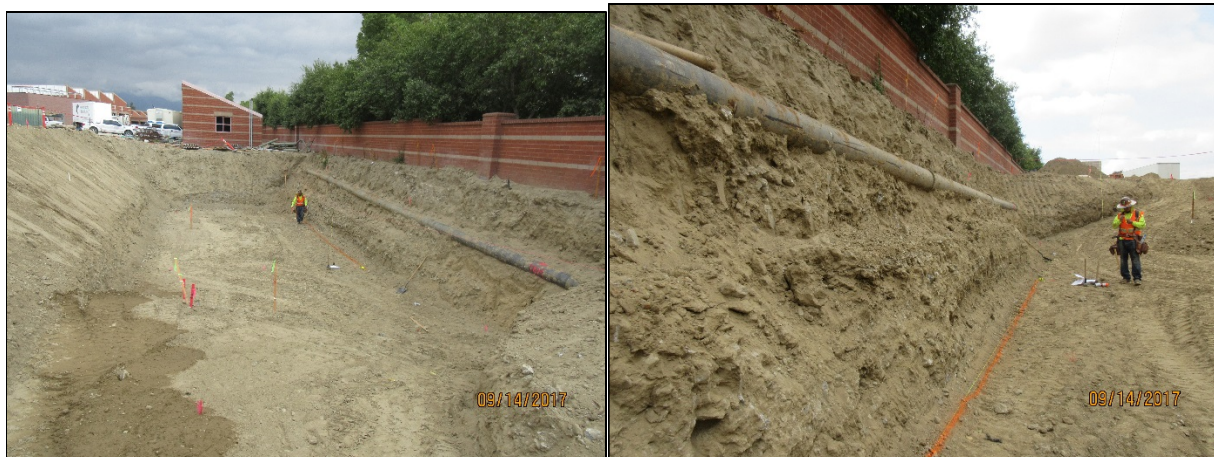
No movement of the wall or the pipe was observed during the excavations, and the sides of the excavation were stable throughout the excavation activities.

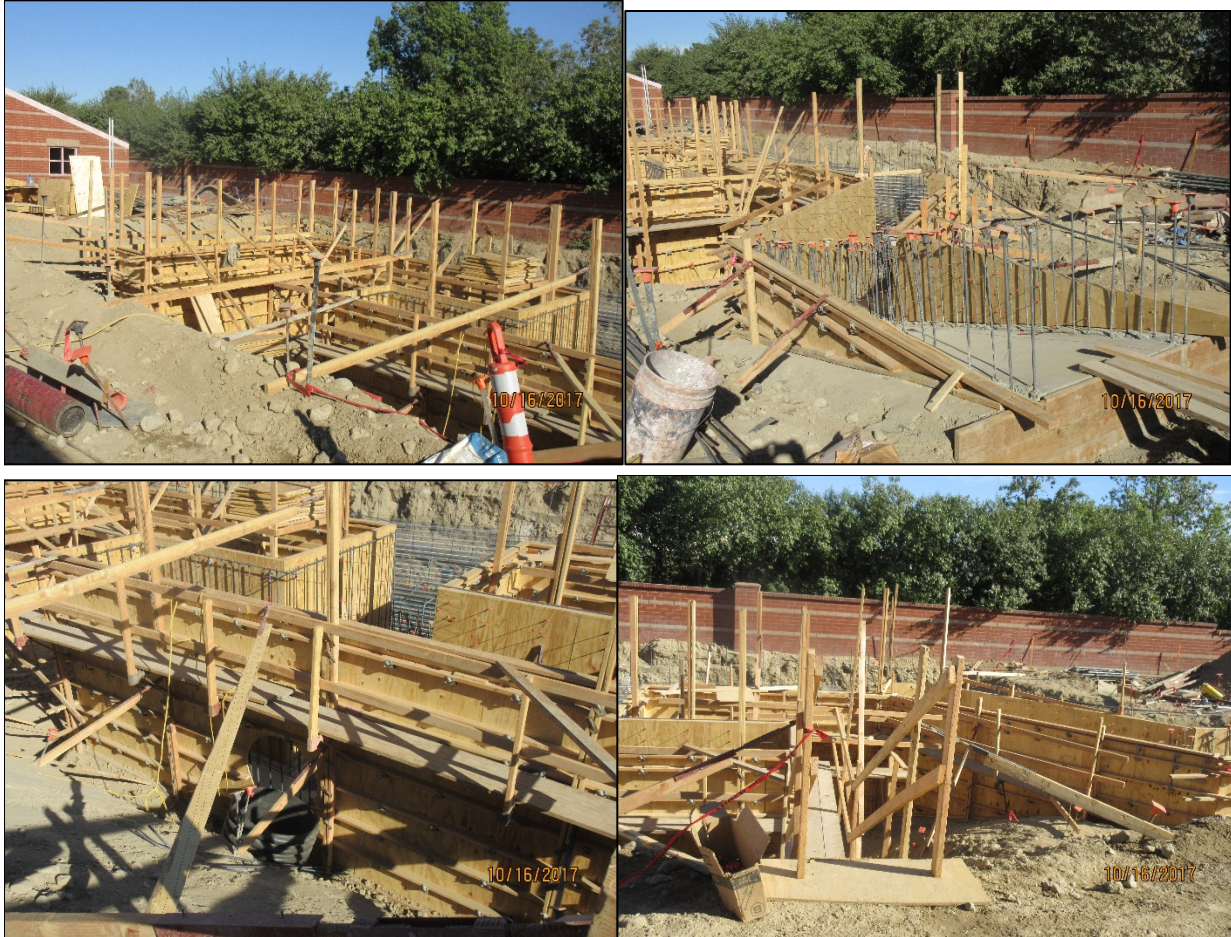
A month later, Helfrich-Associates visited the site to observe the progress of the construction. No significant changes in the slope, wall, or pipe were observed.

The intricate design of the mouse trap is evident and great news... the wall and pipe are still holding strong with no evidence of movement.
